**Report on Inspection of the swimming pools, pool
plant and equipment at the xxxxxx xxxxxxxx Fitness
and Country Club at xxxxxx,,xxxxxxxxxxx,xxxxxxxx in
xxxxxx.**

1 Introduction

1.1 The Brief

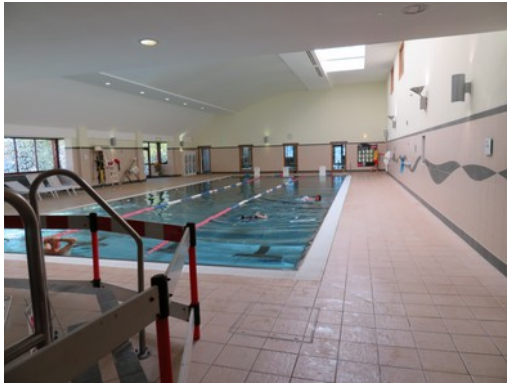
Fitness Pool

The indoor pools have stainless steel walls that are presumably attached to a waterproof floor covering of vinyl or butyl rubber. There was no reason to suspect there are any problematic issues with the pool tanks.

The deck level gutters are covered with white PVC covers that are conventional in design and type. The gutter is also in stainless steel and this makes the cleaning of the scum line in the gutter much easier – the gutters that were inspected were all very clean.

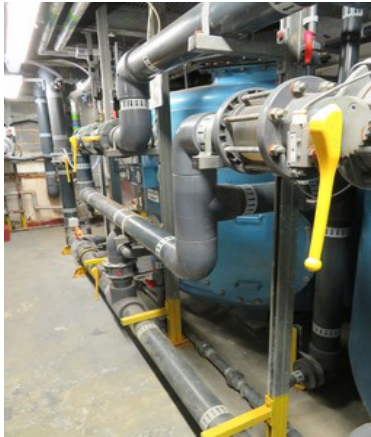
Indoor Pools Filters

The two pools use 2 No 2.1m diameter filters each with a filtration capacity of 82.5 cubic metres of water per hour. These will be capable of filtering the pool water volume in under 2 hours and is satisfactory for a health club swimming pool.

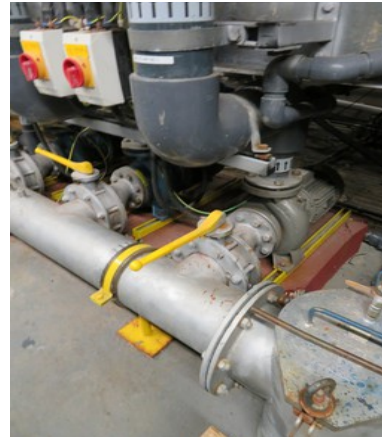
Indoor Pools Pump and manifold

The water is pumped through the system by 3 x 6.5 HP pumps connected to a manifold on the suction side that is connected by 8" pipework to the balance tank. The main drains located in the floors of both pools drain into the balance tank. When the pools were installed the flow from the main drains into the balance tank was controlled by a pneumatically powered valve. The output from the 3 pool pumps was also controlled by pneumatic valves that were adjusted by signals from a transmitter that measured the water level in the balance tank from the pressure of the head of water in the tank. It is understood that the pneumatic control system failed very frequently and has recently been removed from the system. It is not known whether the control that this was designed to provide has been replaced by another system – but that seems very unlikely as there was no evidence of this. Furthermore it is not known whether safety measures have been incorporated in the changed control system to ensure that the balance tank neither overflows or wastes water down the drains.

It is normal practice to connect the main drains in a pool floor to the suction manifold of the main circulation pumps. This enables direct control of the volume of water that comes from the main drains and ensures that the pool water is being continuously circulated throughout the depth of the pool. At xxxxxxxx, this is not possible because the main drains discharge into the balance tank. Hence the more people there are in the pool the less the volume of water that will flow through the filters from the main drains because the flow from the deck level drains will predominate.

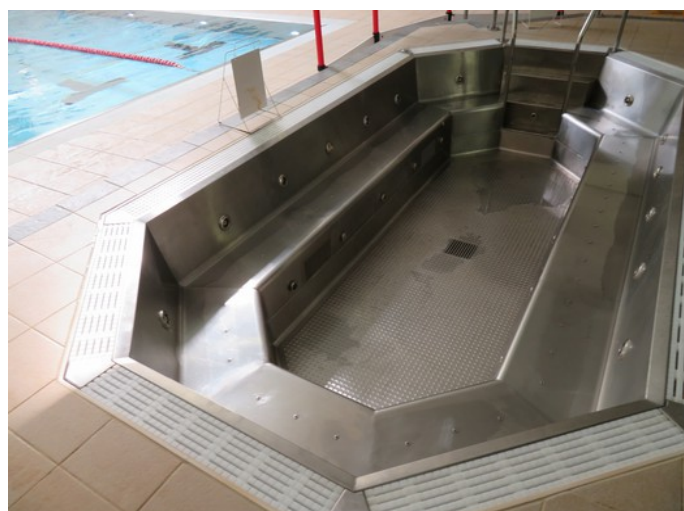
- 1 The spa water is heated by a heat exchanger in the pool plant room that is fed by hot water from the main building heating boilers. There is a temperature sensor shown on the pipework schematics but it is not clear how or if this controls the water temperature and whether it is working or not. The provision of an air source heat pump dedicated to the spa would reduce running costs considerably.

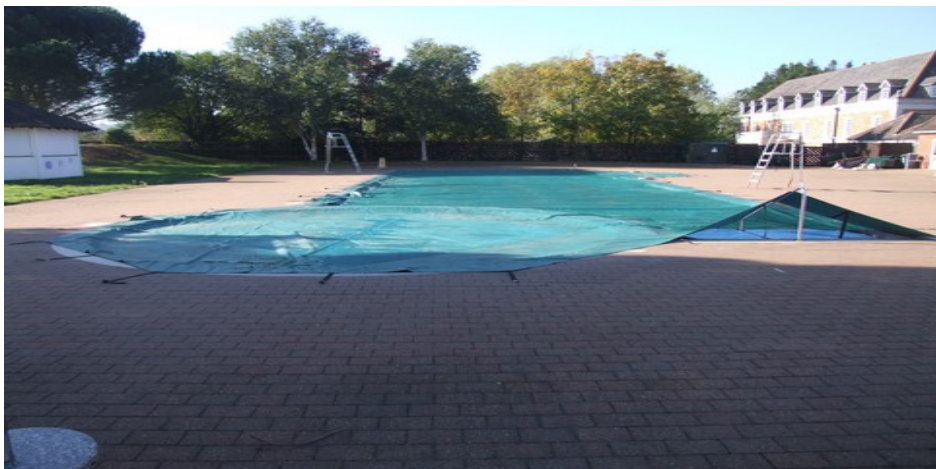
Outdoor Pool

The outdoor pool is understood to be 22.5m long x 7 metres wide and between 1.2m and 1.5m deep with a paddling pool at one end and roman steps. It had been taken out of operation at the end of the summer season and was fitted with a cover so that it could not be inspected.

It is understood that the outdoor pool has recently been retiled and that there are some repairs required under the tiling contract. It is very common for disputes to occur in the re-tiling of pools and it is recommended that the details of this problem are examined to make sure that there is not an ongoing contractual dispute.

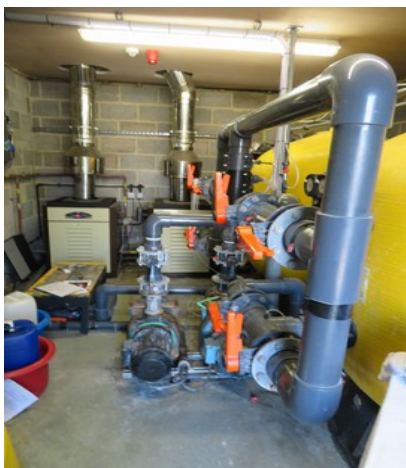
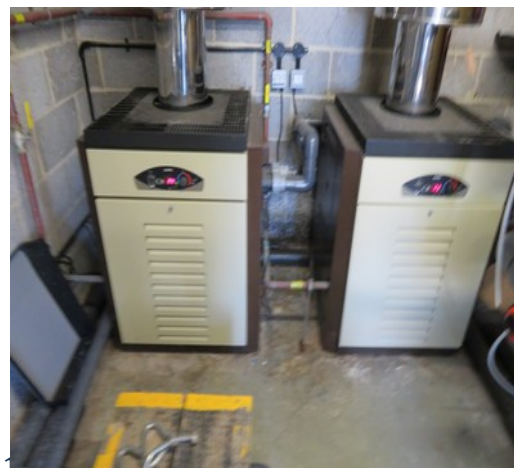
The outdoor pool has a volume of approximately 250 cubic metres of water. It is equipped with 2 No 1.6m diameter filters each with a filtration capacity of 80 cubic metres of water per hour. These will be capable of filtering the pool water volume in less than 2 hours and is satisfactory for a health club swimming pool.

The water is pumped through the system by 2 x 5 HP pumps connected to a manifold on the suction side that is connected by the pipework to the 5 No skimmers and 2 main drains located in the floor of the pool and returning the water to the pool via 6 x returns. This is a conventional system and is satisfactory.
